LITIGATION TECHNICAL SUPPORT AND SERVICES
ROCKY MOUNTAIN ARSENAL

FINAL PHASE I
CONTAMINATION ASSESSMENT REPORT
SECTION 27: NONSOURCE AREA
(Version 3.1)

December 1987
Contract Number DAAK11-84-D0016
Task Number 14 (Army Sites North)

ENVIRONMENTAL SCIENCE AND ENGINEERING, INC.
HARDING LAWSON ASSOCIATES MIDWEST RESEARCH INSTITUTE

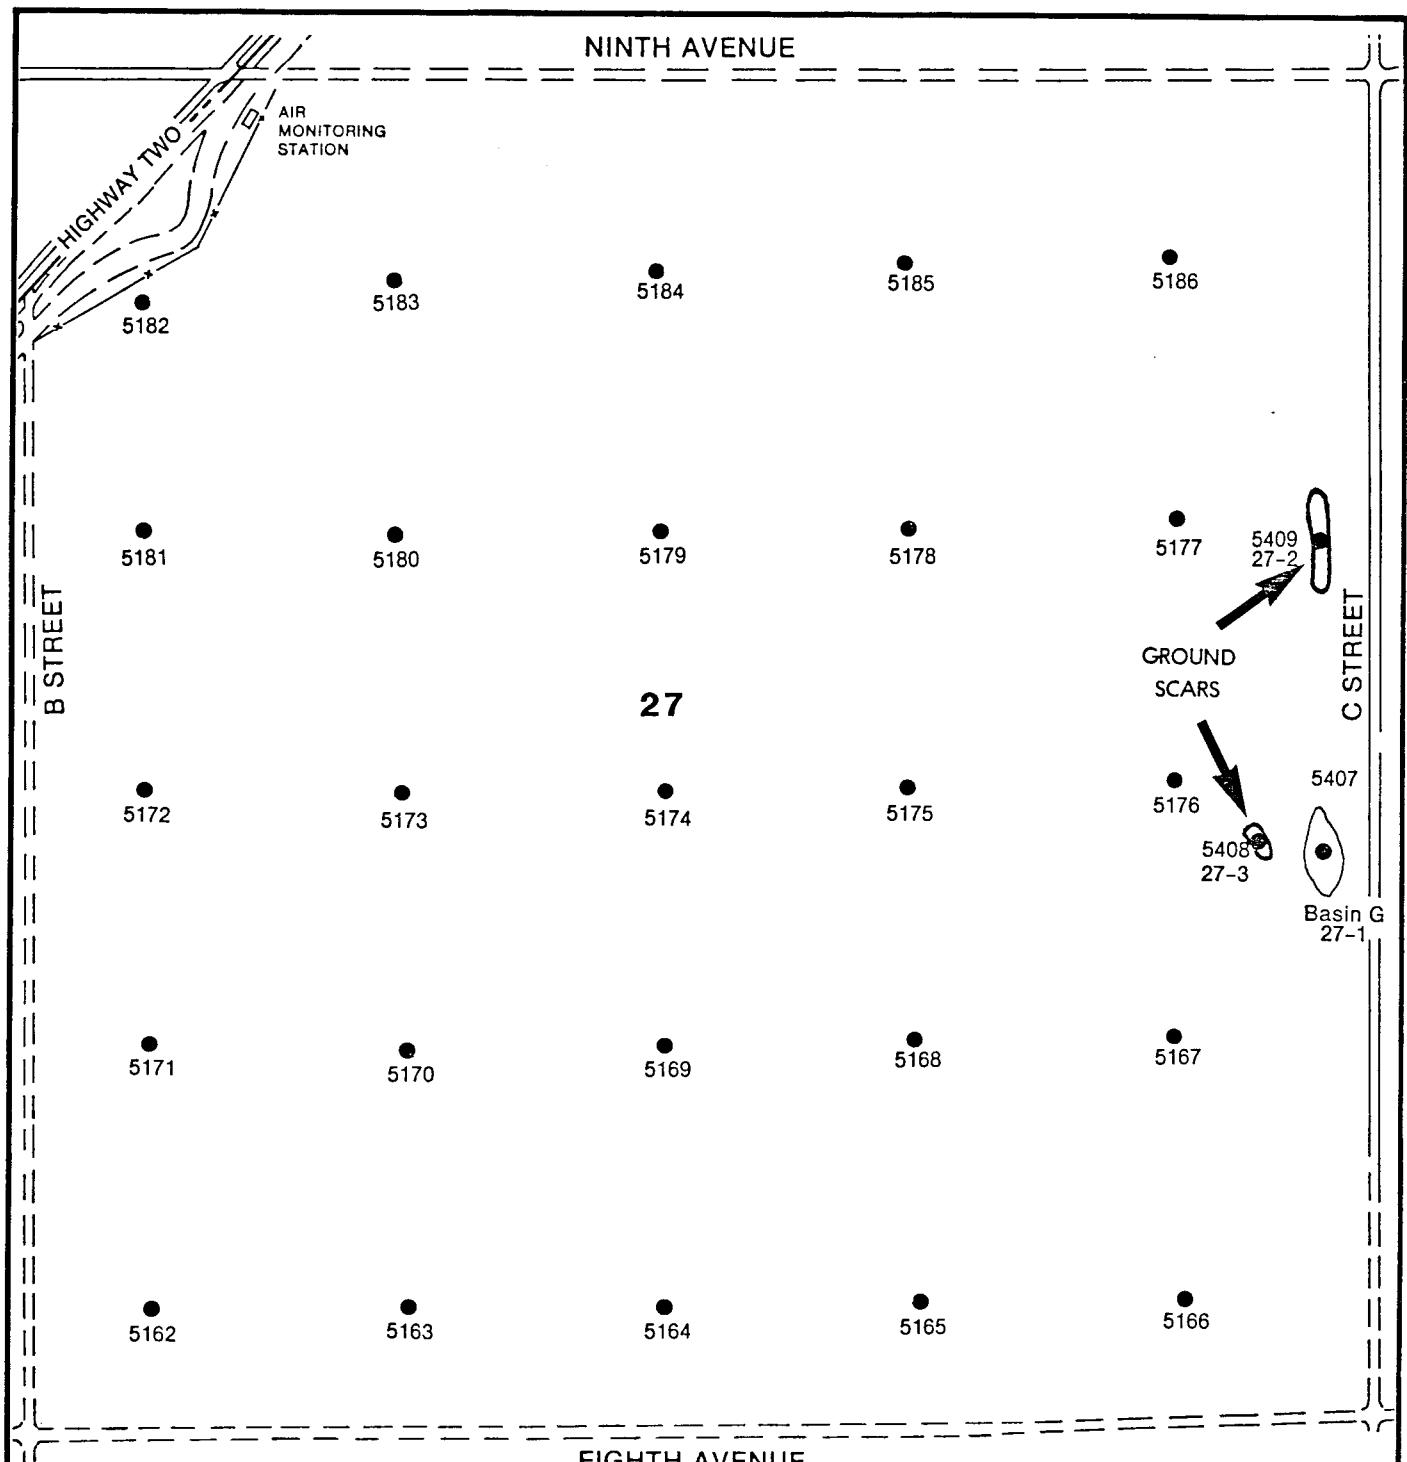
Figure 27-UNC-4
PHASE I INVESTIGATION
BORING LOCATION MAP
SECTION 27-UNC
SOURCE: ESE, 1987

Field observations revealed Section 27 to be essentially undisturbed. No surface discolorations were noted at the ground scar locations or light areas described in the aerial photographs, and no visual contamination was noted in any Section 27-UNC boring. No unusual soil coloration was observed in Basin G, and Boring 5407 (drilled in the low, bare spot of Basin G) did not indicate any evidence of contamination. PID readings were at background levels during drilling at this site.

Phase I chemical results confirm that Section 27 is a nonsource area (Table 27-UNC-3). Boring 5182, the only boring with a compound above its indicator range, contained arsenic at 12 parts per million (ppm), which is slightly above the indicator range. This sample also contained copper and zinc concentrations of 32 and 66 ppm, respectively; however, both values are within their indicator ranges. Cadmium, mercury, lead, and target semivolatile organic compounds were not detected in any of the 28 samples.
